WOOD POLE

WOOD POLES: HOW LONG DO THEY LAST?

WOOD POLE LIFE SPAN: WHAT YOU CAN EXPECT

By Andrew H. Stewart, Director of Engineering
Engineering Data Management - Fort Collins, CO

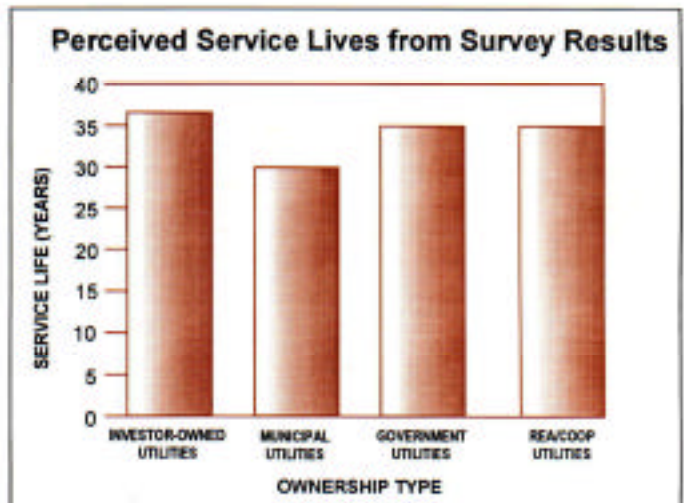
Figure 1. Average perceived service lives of wood poles in various geographical regions of the U.S. (determined through a survey of electric utility industry personnel).

Several utility industry surveys have been conducted in the last 15 years seeking information on the perceived performance of various structure materials used in the construction of transmission and distribution lines. Most of these have requested information on the perceived service life of wood poles. The relevant results of a representative survey are summarized in Figures 1 and 2.

The results of this survey were compiled based on responses from approximately 80 investor-owned utilities, 30 municipal utilities, 15 government utilities and 25 REA cooperatives.

Examination of the results reveals an average perceived life of 33 years. When regional differences are considered, a range of average service lives from 28 to 37 years is observed. The most common reason for pole replacement was cited as "strength degradation due to groundline decay."

Comparison of the perceived service lives of wood poles in Figures 1 and 2 to the actual pole replacement data presented in Table 1 reveals some very significant differences.

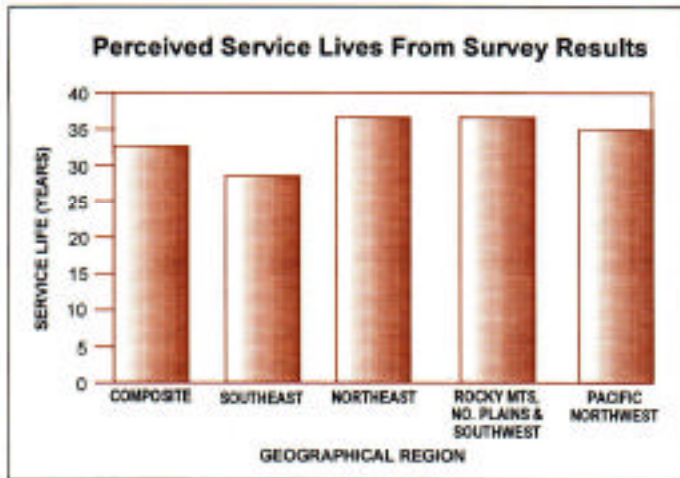
Figure 2. Average perceived service lives of wood poles within various ownership classifications of electric utilities (determined through a survey of electric utility industry personnel).

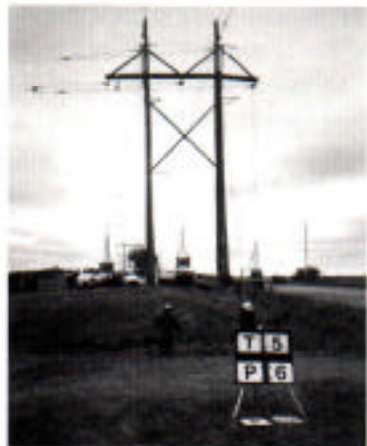
Full scale tests of 62-year old 115kV H-frames at Nebraska Public Power District (conducted by Engineering Data Management, Inc. and Hughes Brothers, Inc.)
